## **Repairs and Improvements at St Cecilia's**

This short report details some recent work on and around our church. It doesn't cover everything which has been done, but it does report on some of the major works.

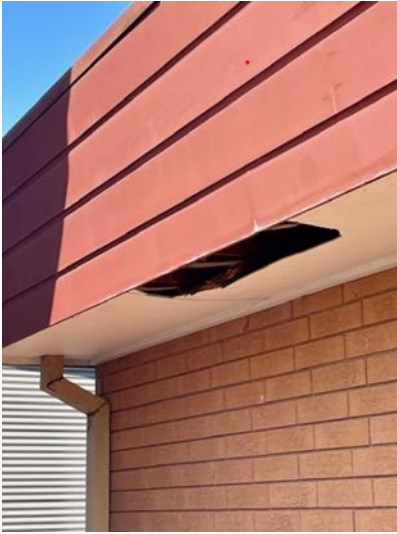
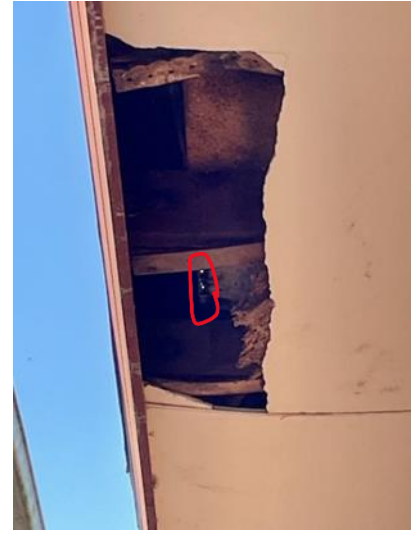
These are two photos from September last year. They're both from the back of the north side of our church.

The soffit is the underside of the roof edge. You can see in the photo on the left that some material had fallen from the soffit, leaving it damaged.

The photo on the right reveals the cause of this damage. The gutter is directly above this damage, and it had two holes in it. These are circled in red. Water leaked through the gutter, saturated the soffit, and caused it to fail.

Our handymen inspected all the gutters on the church roof. They found damage in other areas of the gutters which was similar to the above. At least 20% of the gutters had to be replaced. All the rest have been coated with a bituminous waterproof membrane. This should preserve them and keep them waterproof.

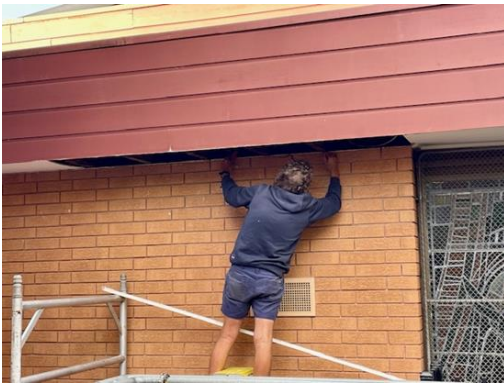
You can see in the photo that they had to remove more of the soffit which was also water-damaged. They then skilfully inserted a new piece.

The final step was repairing the soffit.

Two of our handymen worked on this on 10 April 2025.

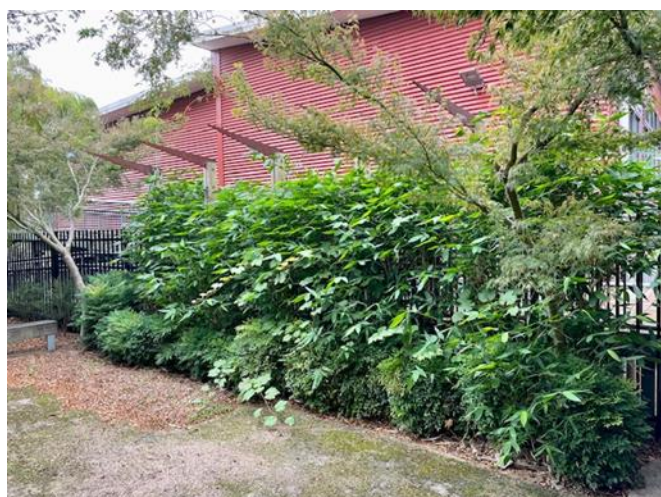
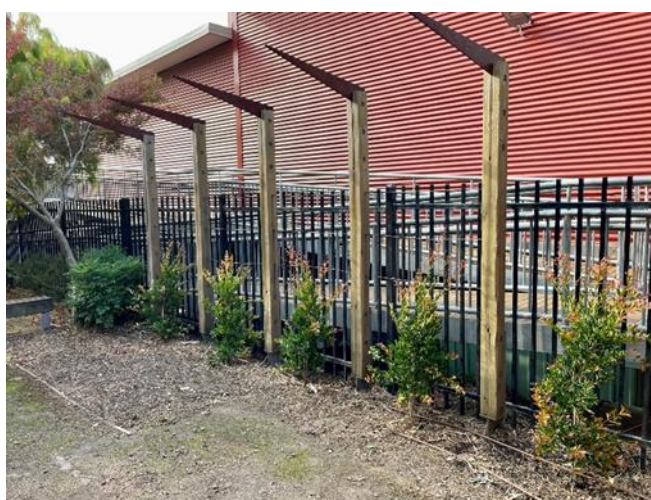
Ever Bloom Horticulture provides the gardeners for our school and church. They helped us to select Lilly Pilly Firescreen as the plant for this hedge. Their team came here on 16 May 2025. They worked hard to remove the bamboo and grapevine. They had purchased five Firescreen plants for us, and planted them. Here are before and after photos:
